*Phase I and II, and Records Research Report – Former
Naval Air Station and Vicinity*

**PHASE I ENVIRONMENTAL
SITE ASSESSMENT
600 ROHNERT PARK EXPRESSWAY
ROHNERT PARK, CALIFORNIA**

Kleinfelder Job No: C41-5098-01/001
June 18, 2002

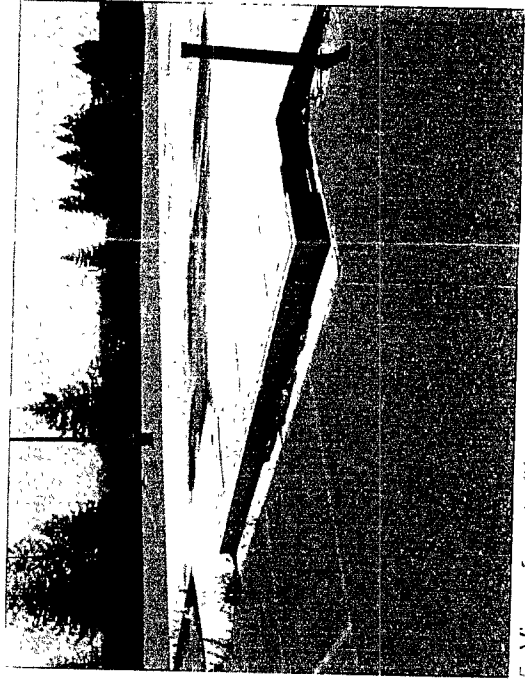
5. View of east oil/water separator

Two oil-water separators on either side of the equipment staging area were nearly full at the time of the site visit. Metal plates prevented full access to the oil-water separators, and Kleinfelder could not observe the condition of the water.

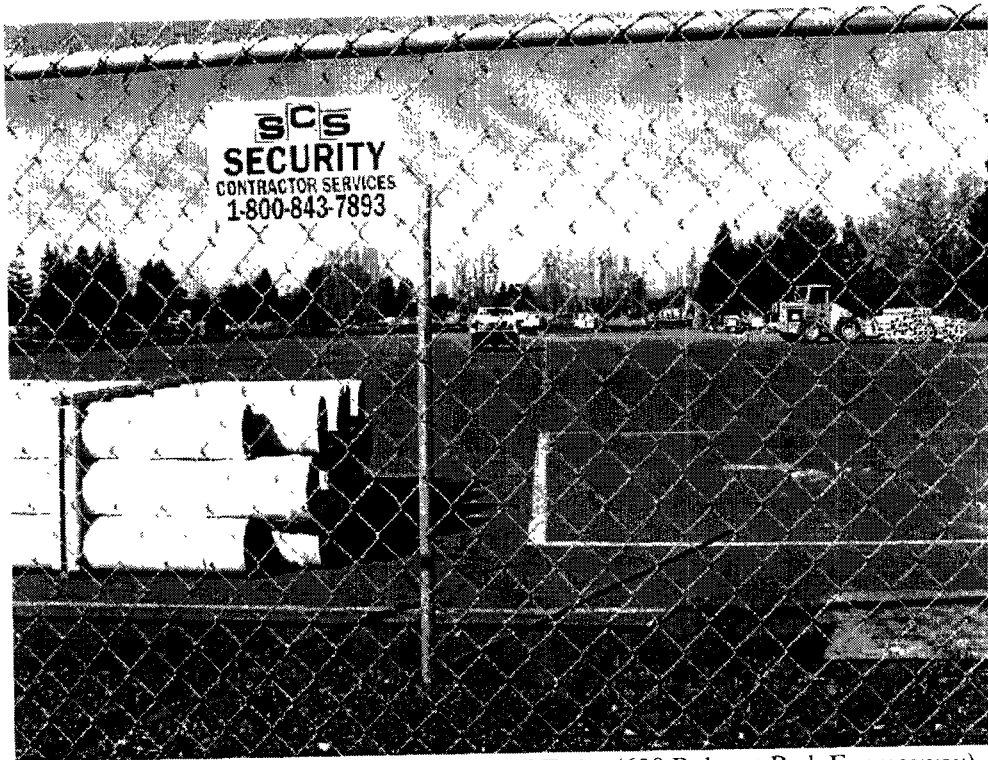
Looking west at construction on former PG&E site (600 Rohnert Park Expressway).

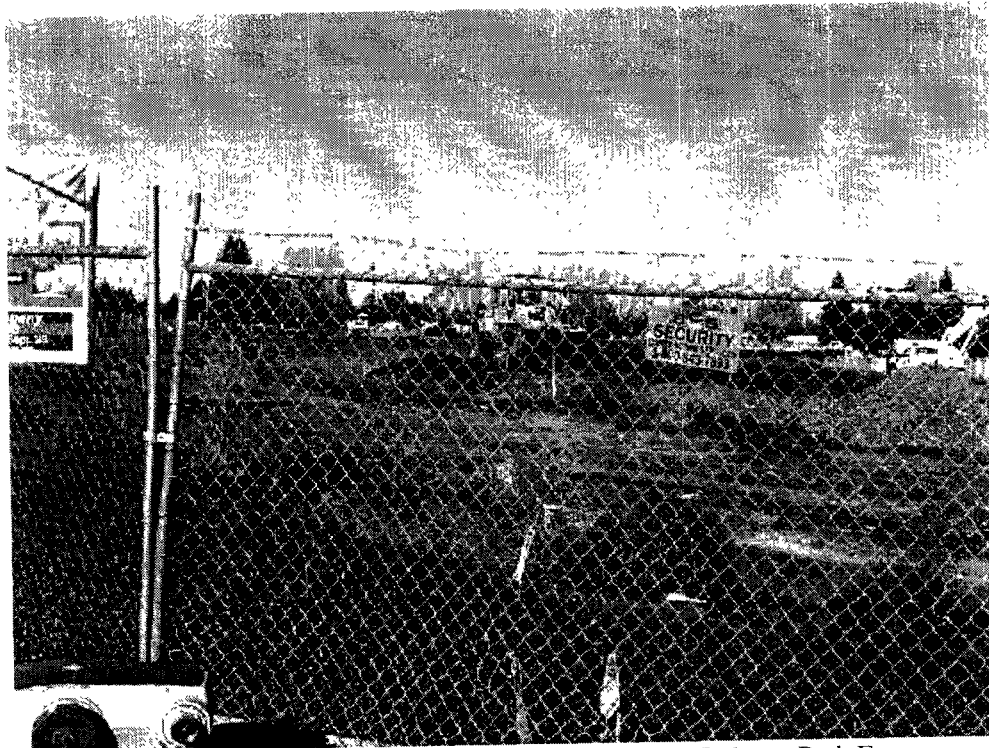
Looking west at construction at former PG&E Facility (600 Rohnert Park Expressway)

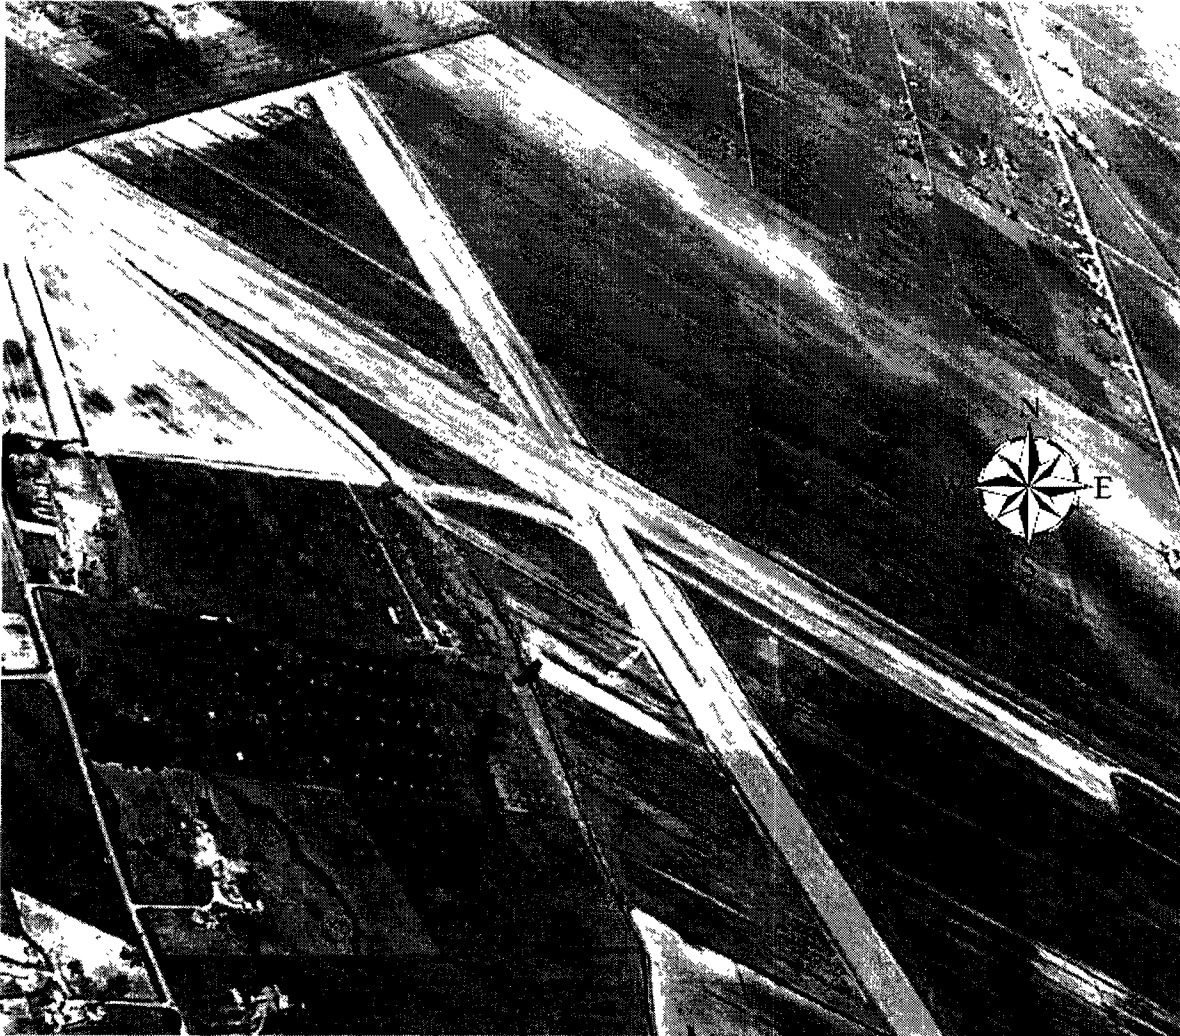
Aerial Photograph Dated 1942. This photograph was taken prior to the construction of any buildings or tanks. The runway layout is visible, but the concrete apron has not yet been constructed. Lands in agricultural production (primarily hay fields) border the site on the northeast and southeast, and rural residences border the site on the southwest border of the facility along with a drainage ditch, used possibly for flood control purposes.
